BOILER FAILURE ANALYSIS & RECOMMENDATION

A LIST of CHRONIC TROUBLES & REASONS

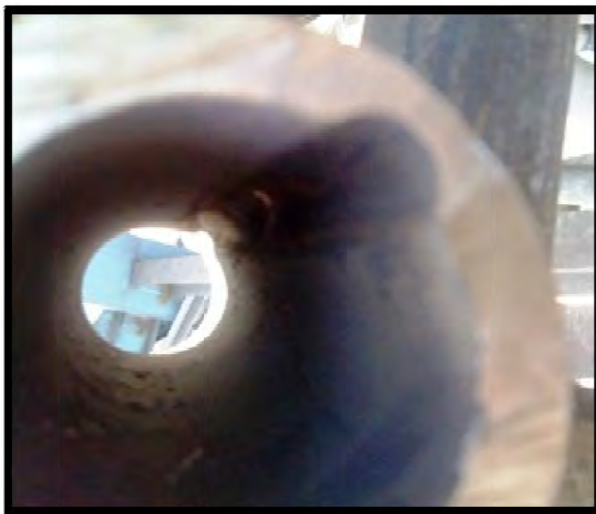
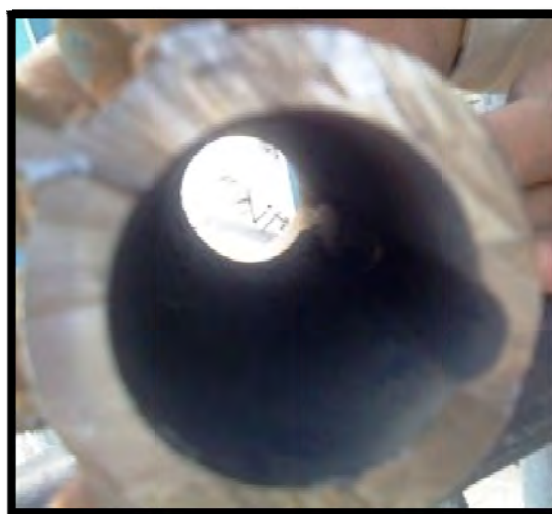
1. AFBC BOILER - WORKING PRESSURE 87KG/CM²g

This is not Caustic Gouging, it's TWO PHASE FAC.

Bed Coil Failure, Mainly due to Improper/Disturbed Circulation & High Heat Flux by High GCV Imported Coal firing, Corrected by RIFLE TUBES

Tube failed location is exactly 12 O'clock position

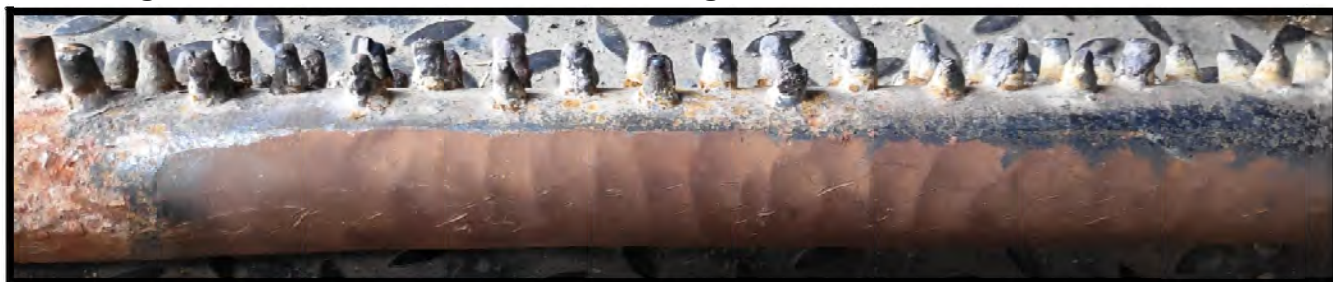
Bed Coil Failure, Mainly due to Improper / Disturbed Circulation & High Heat Flux with Rice Husk firing

BEFORE CUT IN TWO HALVES, EROSION BY HIGH METAL TEMPERATURE

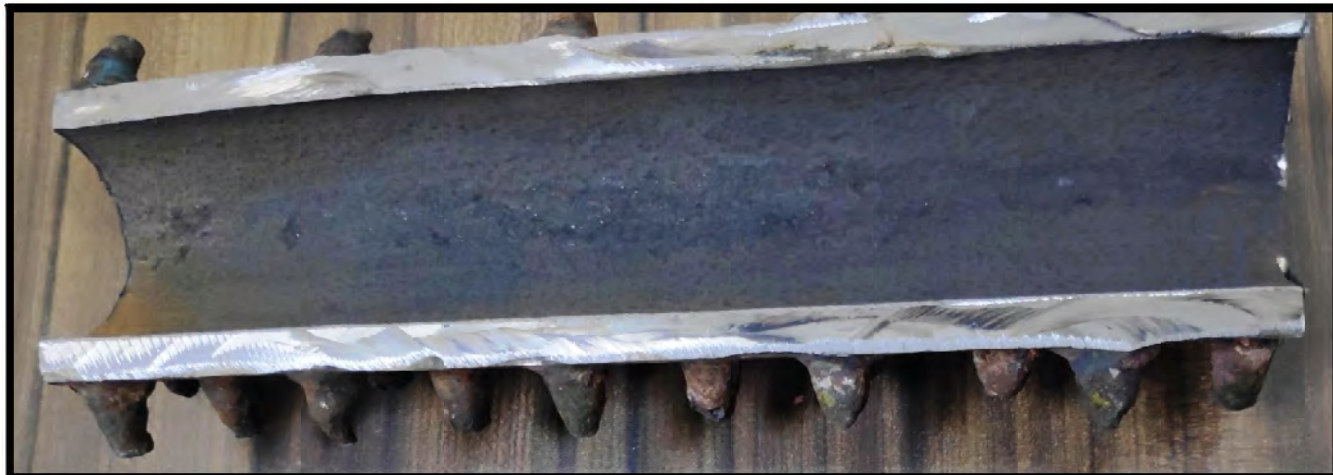
BOTTOM HALF PORTION AFTER CUT IN TWO HALVES, INTERNAL DEPOSITION BY IMPROPER CIRCULATION

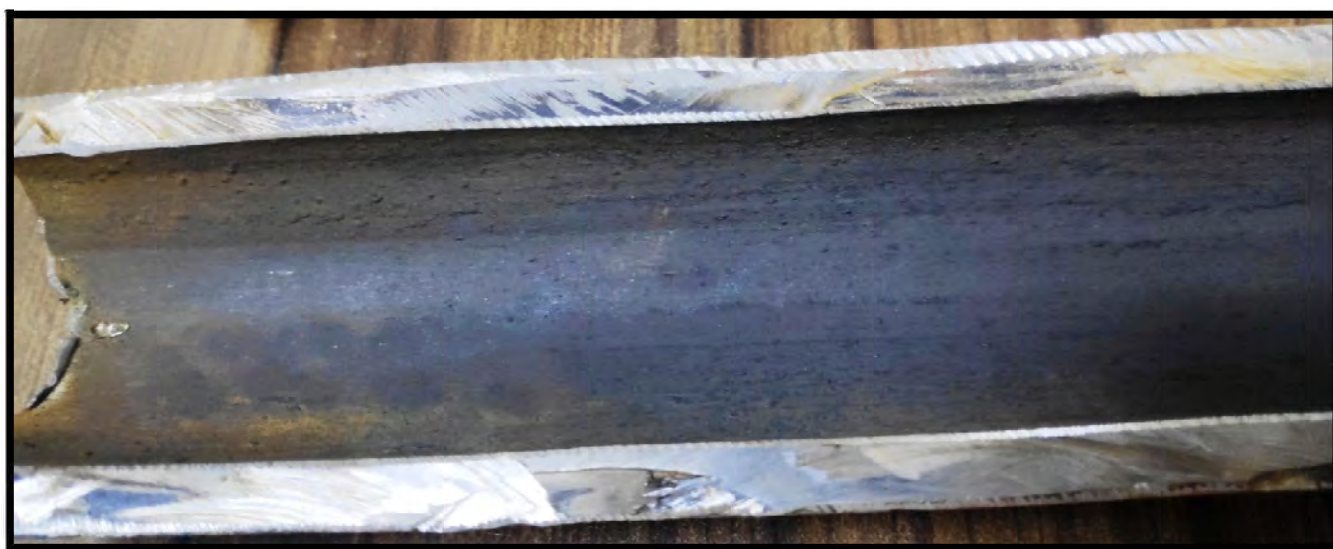
Tube failed location is exactly 12 O'clock position
TOP HALF PORTION AFTER CUT IN TWO HALVES, DEEP GROOVE BY FAC & IMPROPER CIRCULATION

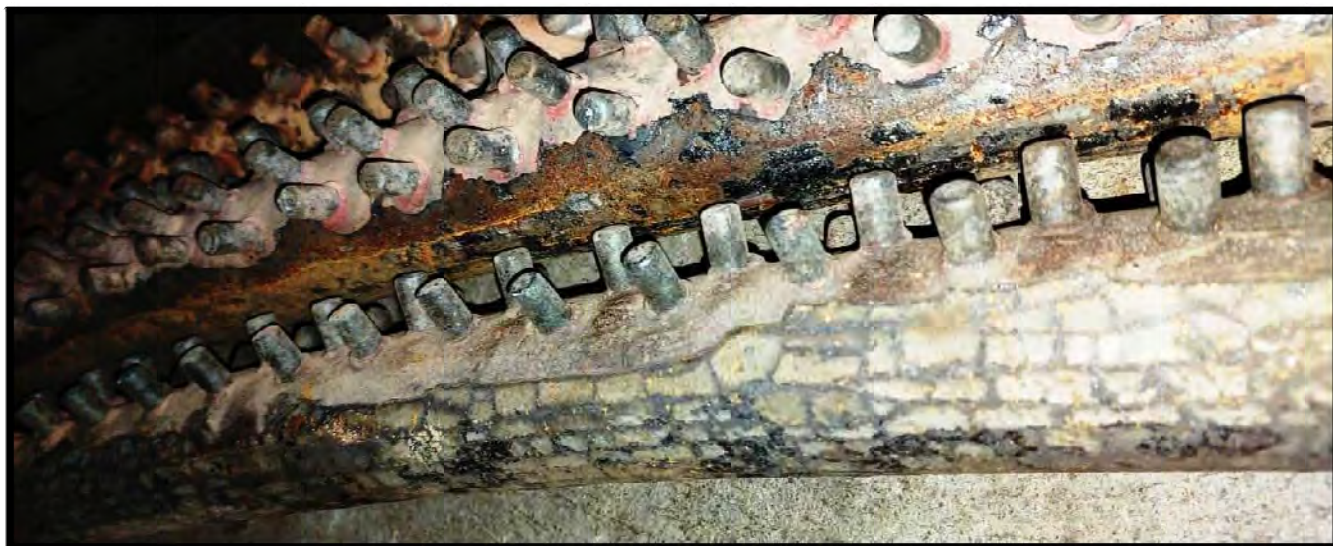
3. AFBC BOILER - WORKING PRESSURE 32KG/CM²g

Bed Coil Failure, Mainly due to Improper / Disturbed Circulation

Tube failed location is exactly 12 O'clock position

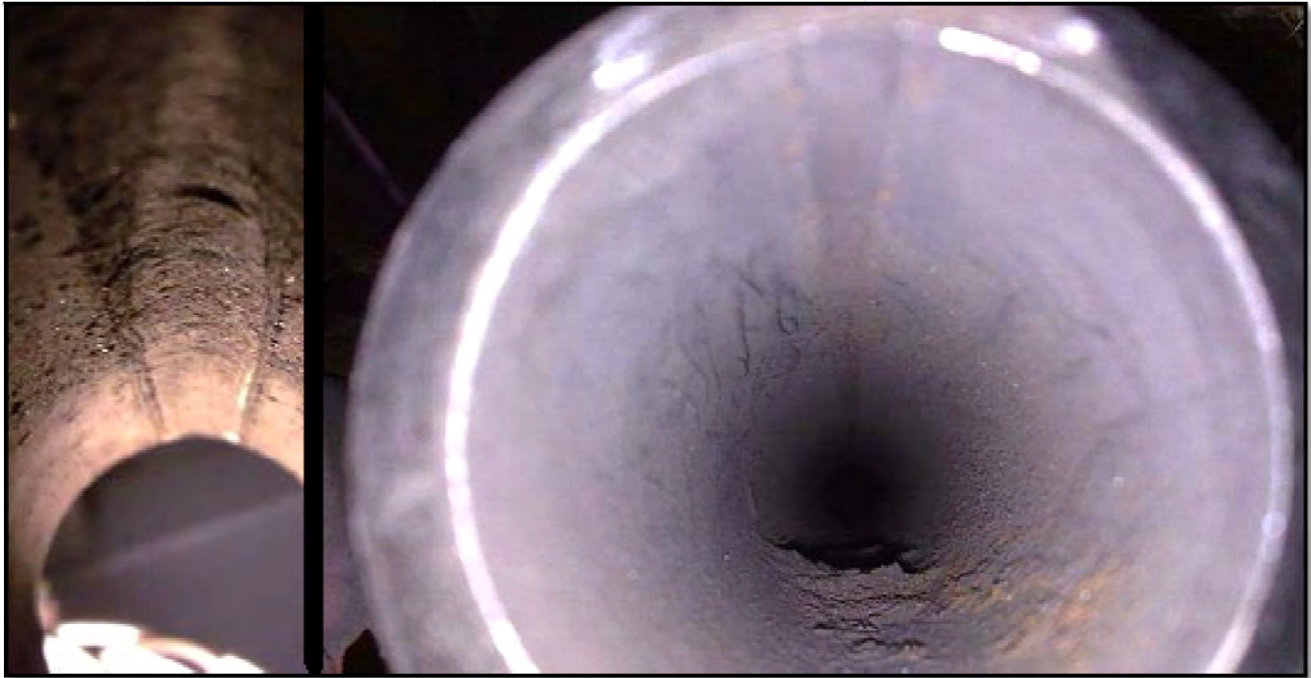
Tube failed location is exactly 12 O'clock position
